FLOWER GARDEN BANKS NATIONAL MARINE SANCTUARY DRAFT - POST HURRICANE IKE QUICK LOOK CRUISE REPORT

OCTOBER 17, 2008

Prepared by Emma L. Hickerson

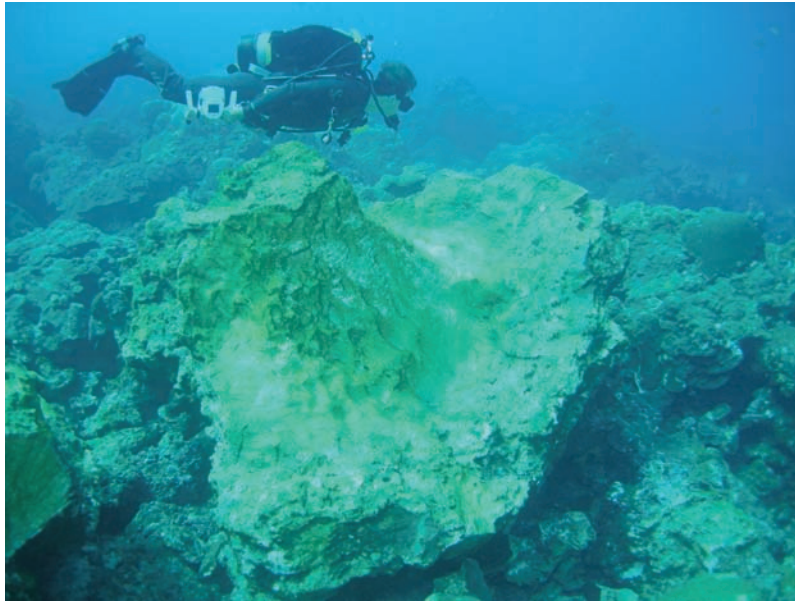
East Flower Garden Bank Buoy #2

Figure 6. *Eric McHugh hovers over a large upturned boulder coral very close to EFGB mooring #2 (October 2008).*

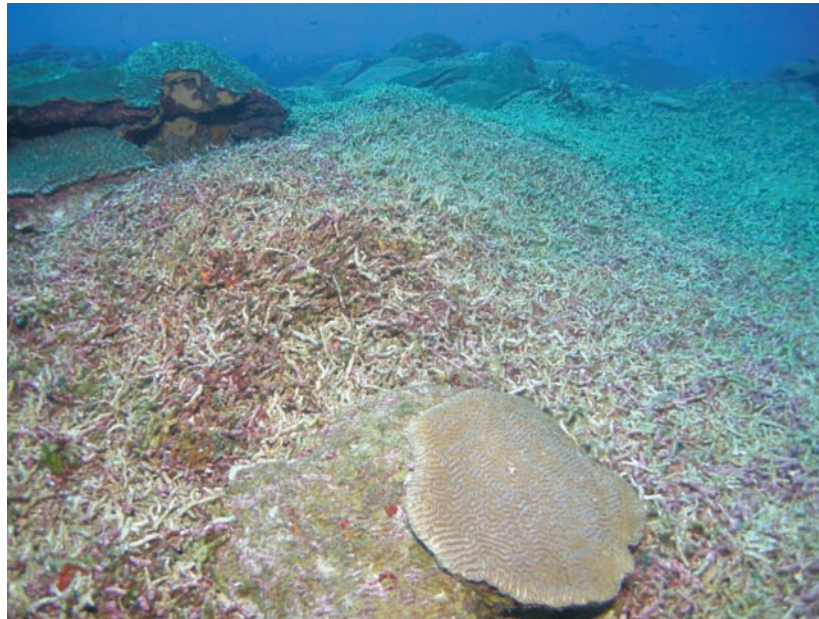
Figure 7. *Field of yellow pencil coral (Madracis mirabilis) are seen broken in place due apparently to downward forces produced by the storm. This field was in similar condition after Hurricane Rita in 2005, but had recovered substantially by August 2008, prior to Hurricane Ike (October 2008).*

In August 2008, the FGBNMS research team dove on the *Madracis* field at EFGB and had commented on the healthy condition observed – an indication that the species was recovering from the injury after Rita in 2005. We have also been observing the regrowth of the large barrel sponges, *Xestospongia muta*, since Rita. Based on the post-Rita and Ike observations on the reef crest at the Flower Garden Banks, we have a better understanding of what has shaped the reef over thousand of years, what is driving the shape of the individual colonies, and the level of resilience and recovery capabilities this coral reef has.

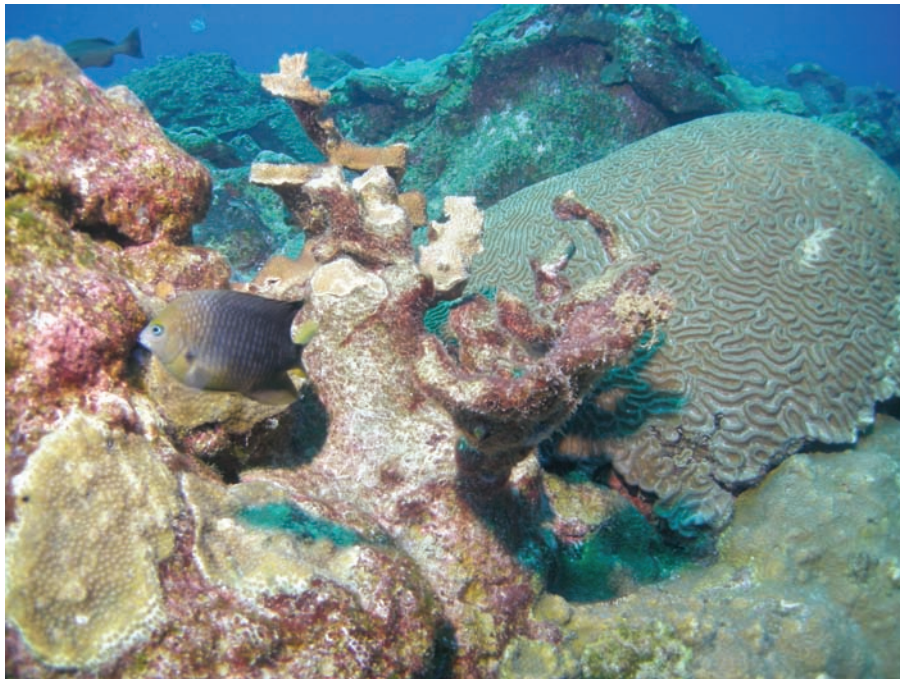
Figure 9. *The only living Acropora palmata known at the East FGB – north side has been farmed by threespot damselfish. South side of colony appears in good health. Branches of colony were lost during storm (October 2008).*

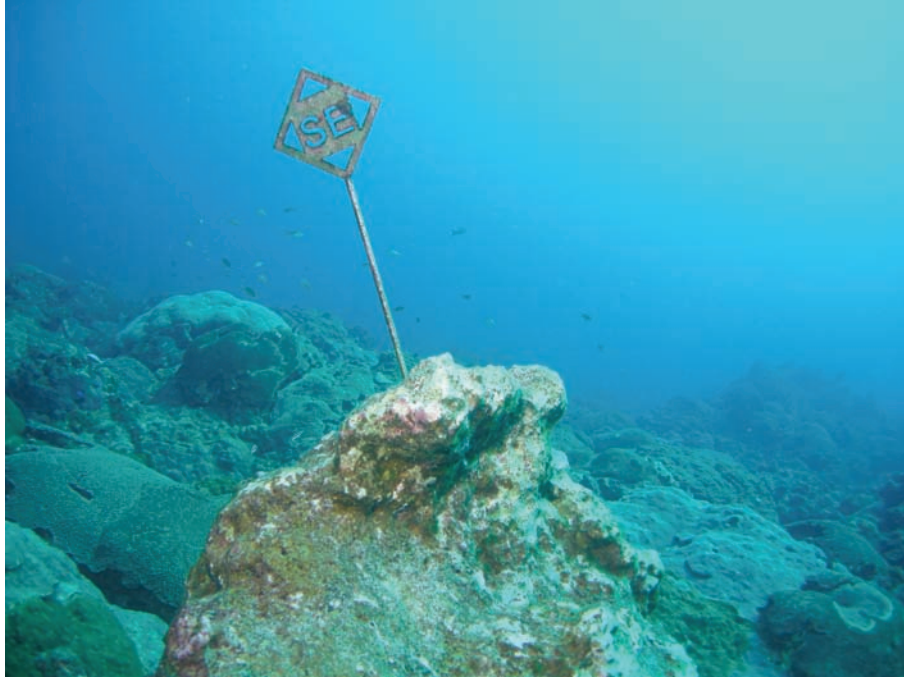
The SE corner post on the long-term monitoring study site at EFGB was in place, although bent. It is unknown at this time what the status is of the other corner posts. Multiple long-term monitoring stations were observed, but many were bent. The study site at WFGB was not surveyed. YSI and Seabird instruments were partially buried and need to be lifted and repositioned on the sandflats at EFGB#4/5 and WFGB#2. The acoustic receivers were both still intact and functioning.

Figure 12. *SE corner marker of the study site at the East FGB, slightly askew (October 2008).*

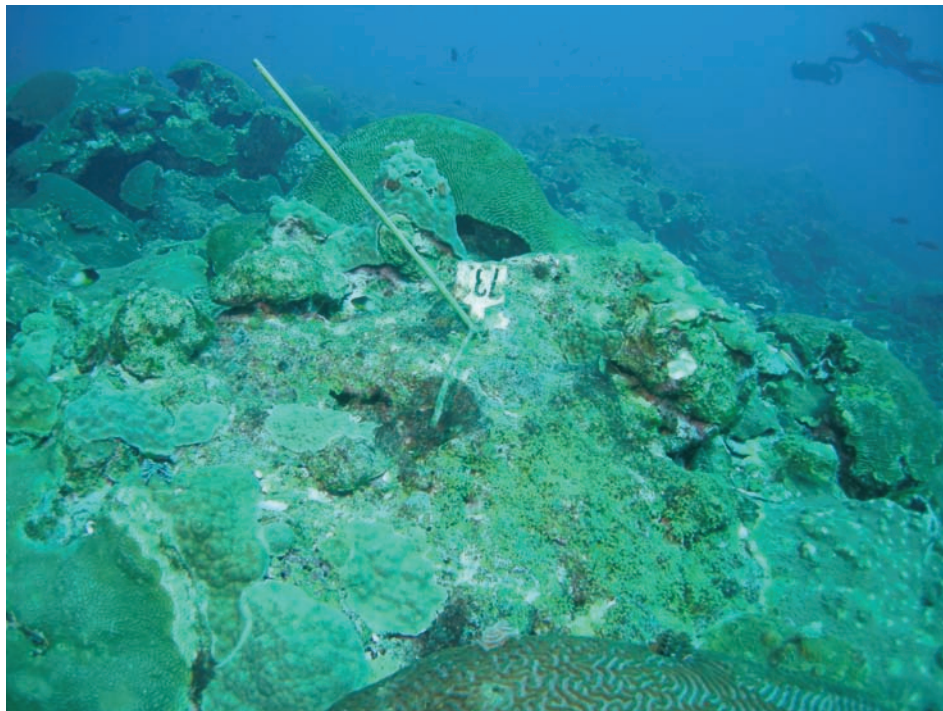
Figure 13. *Long term monitoring repetitive station pin, bent in place (October 2008).*

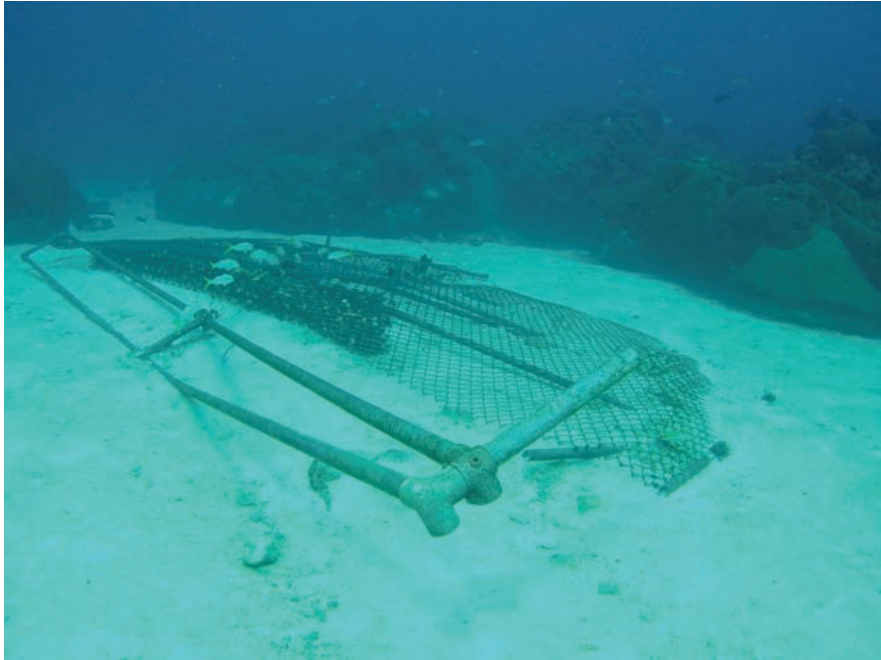
Figure 14. *Remains of recruitment rack, study site for University of Calgary student, Sarah Davies (October 2008).*

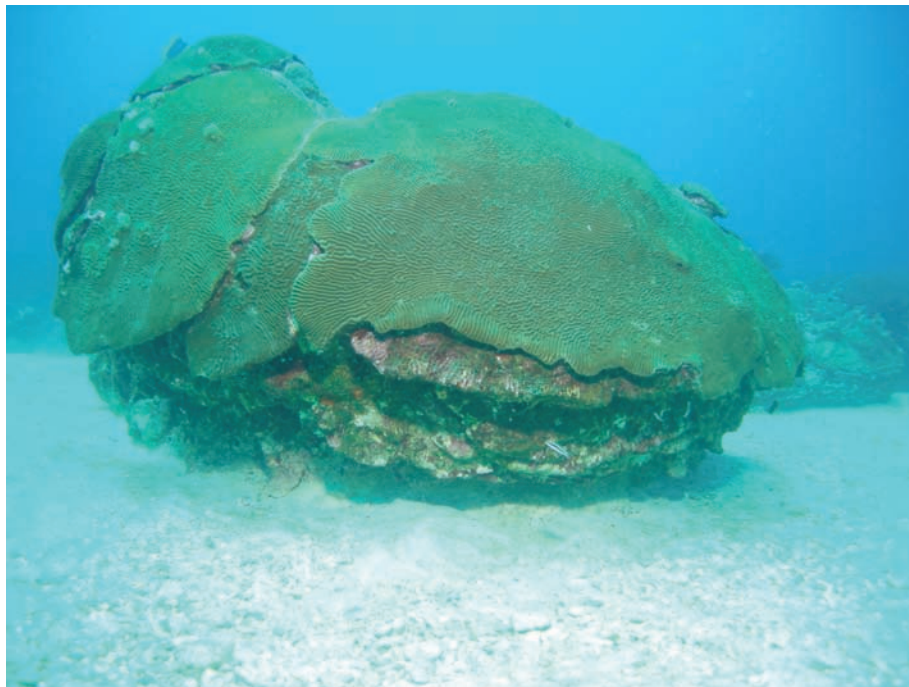
Figure 17. *Scouring around a large coral outcropping on the sand flat between buoy numbers 4 and 5 at the EFGB (October 2008).*

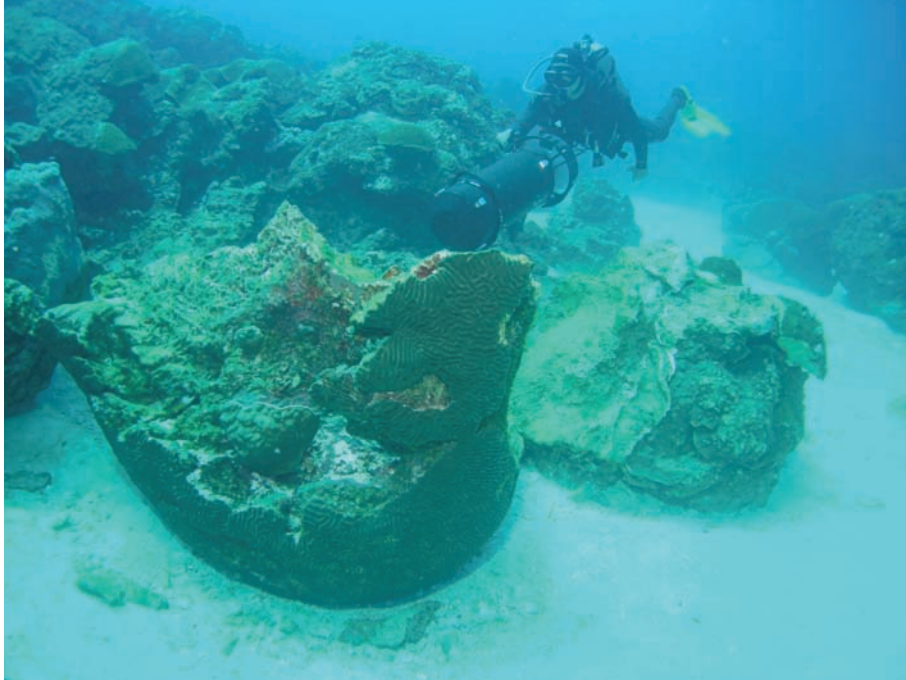
Figure 18. *Captain Darrell scooters over a large brain coral colony (Colpophyllia natans) toppled in the sand flat (October 2008).*

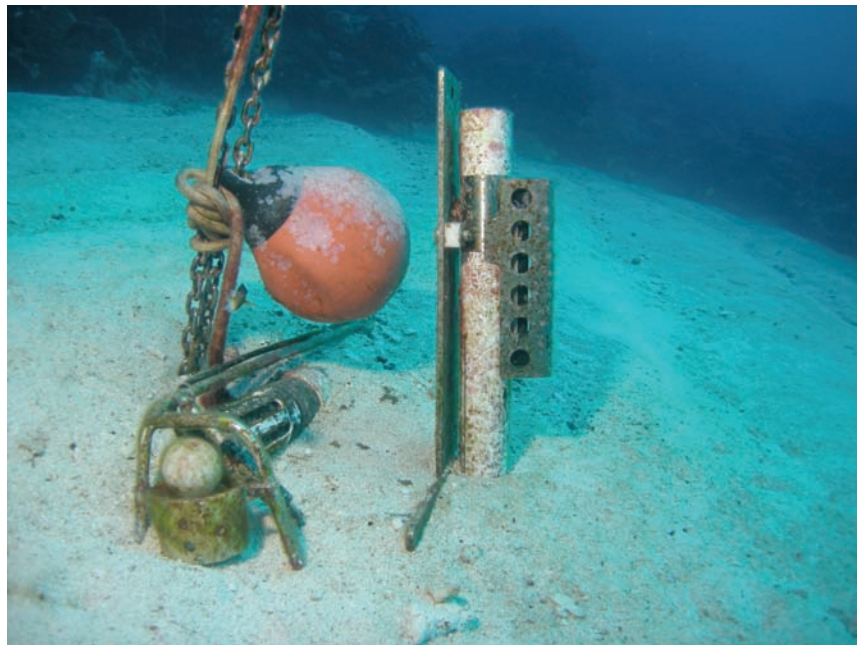
Figure 19. *The YSI and Seabird water quality instrument partially buried in sandflat at buoy #2 on WFGB (October 2008).*

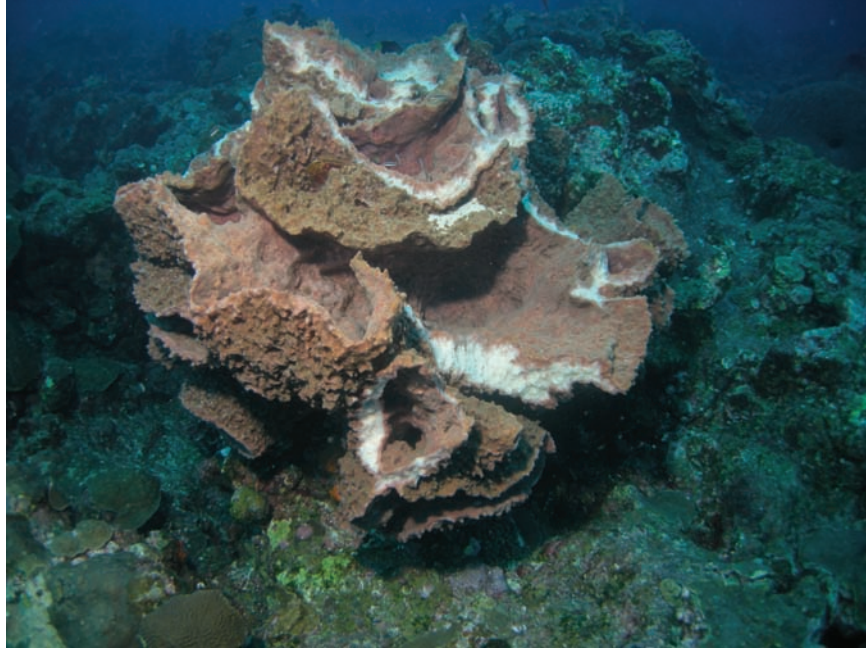
Figure 20. *Giant barrel sponge, Xestospongia muta, exhibiting exposed tissue where portions of the barrels have been sheared off during the storm. This is the sponge that is on the southeast side of the West FGB Acropora palmate (October 2008).*

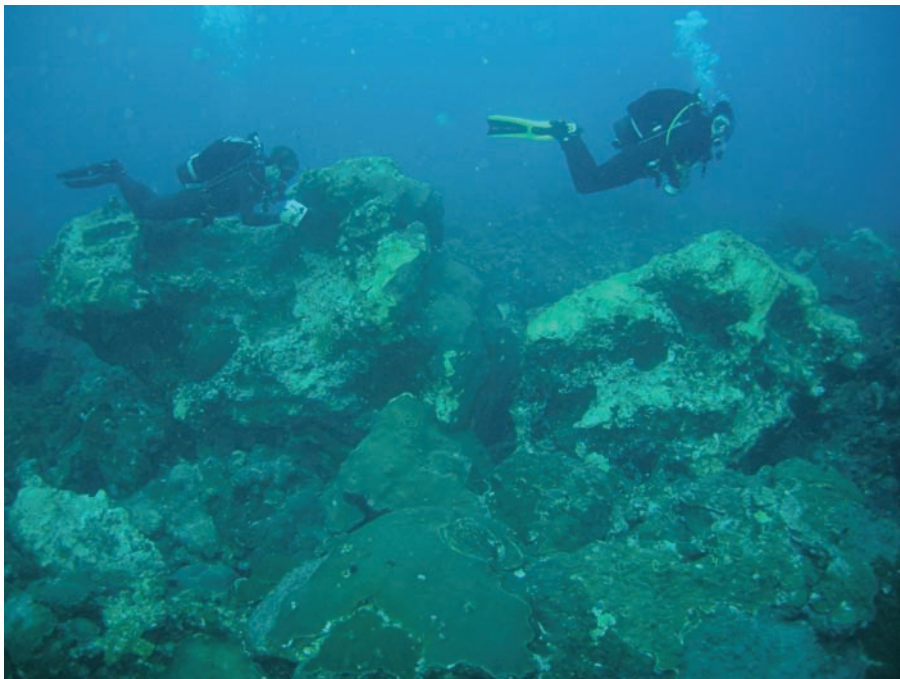
Figure 25. *Eric McHugh and Marissa Nuttall hover over large boulders of dislodged corals close to the WFGB#2 mooring (October 2008).*

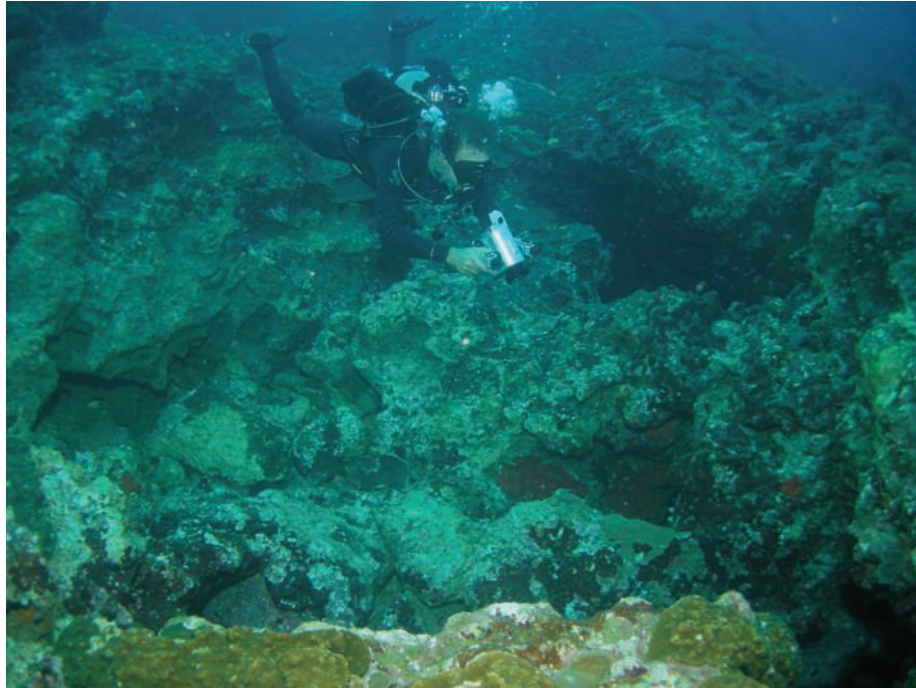
Figure 26. *Eric McHugh shoots video inside a crater left behind by a dislodged boulder coral (October 2008).*

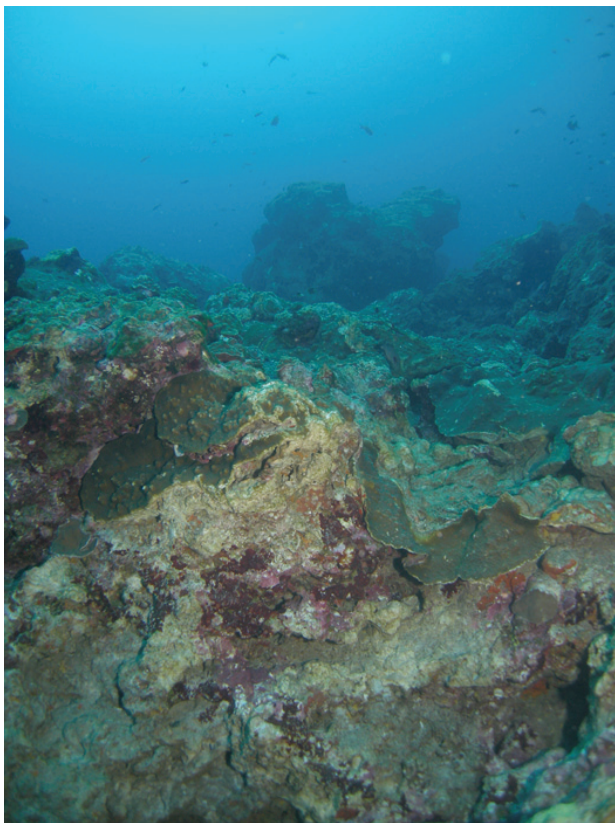
Figure 27. *Inside the crater looking southwest towards the coral colony that was dislodged, approximately 25 feet away (October 2008).*

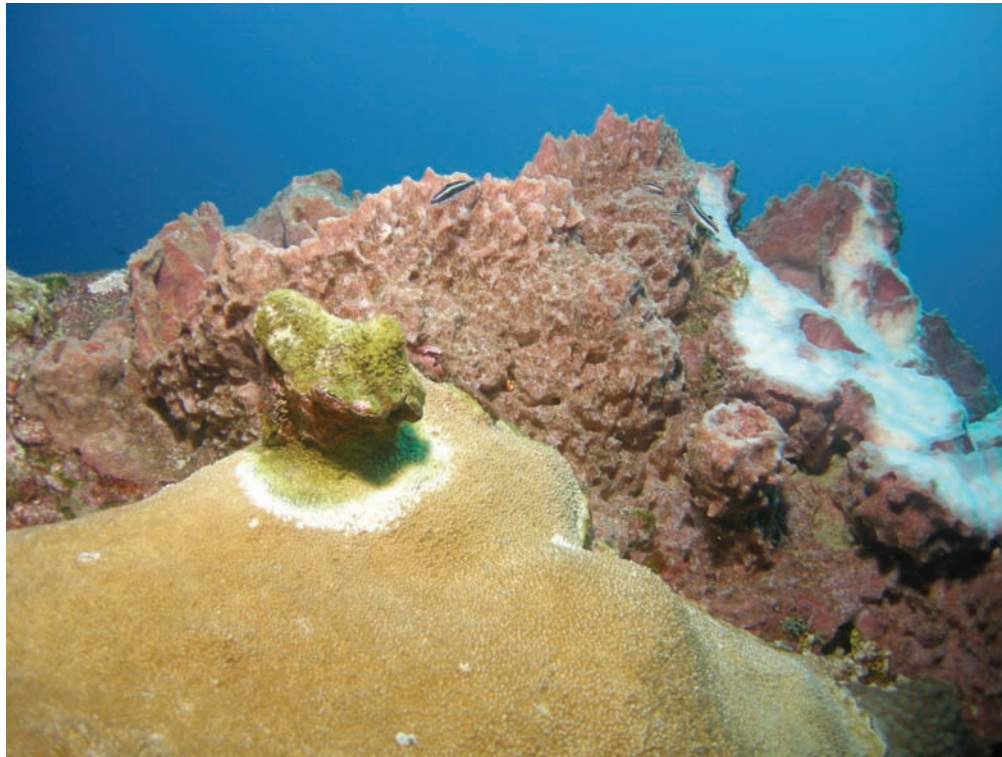
Figure 28. *On the right the exposed tissue of the sponge caused by shearing during Hurricane Ike is seen, the left side of the sponge shows the recovery of barrels that were sheared off in September 2005 during Hurricane Rita. In the foreground, details of the malady exhibited around the “horn” of the WFGB Acropora palmata is shown (October 2008).*
